Airworthiness Directive

AD No.: 2024-0081

ATR 42 and ATR 72 aeroplanes

ATA 27 – Flight Controls – Rudder Travel Limiting Unit – Inspection

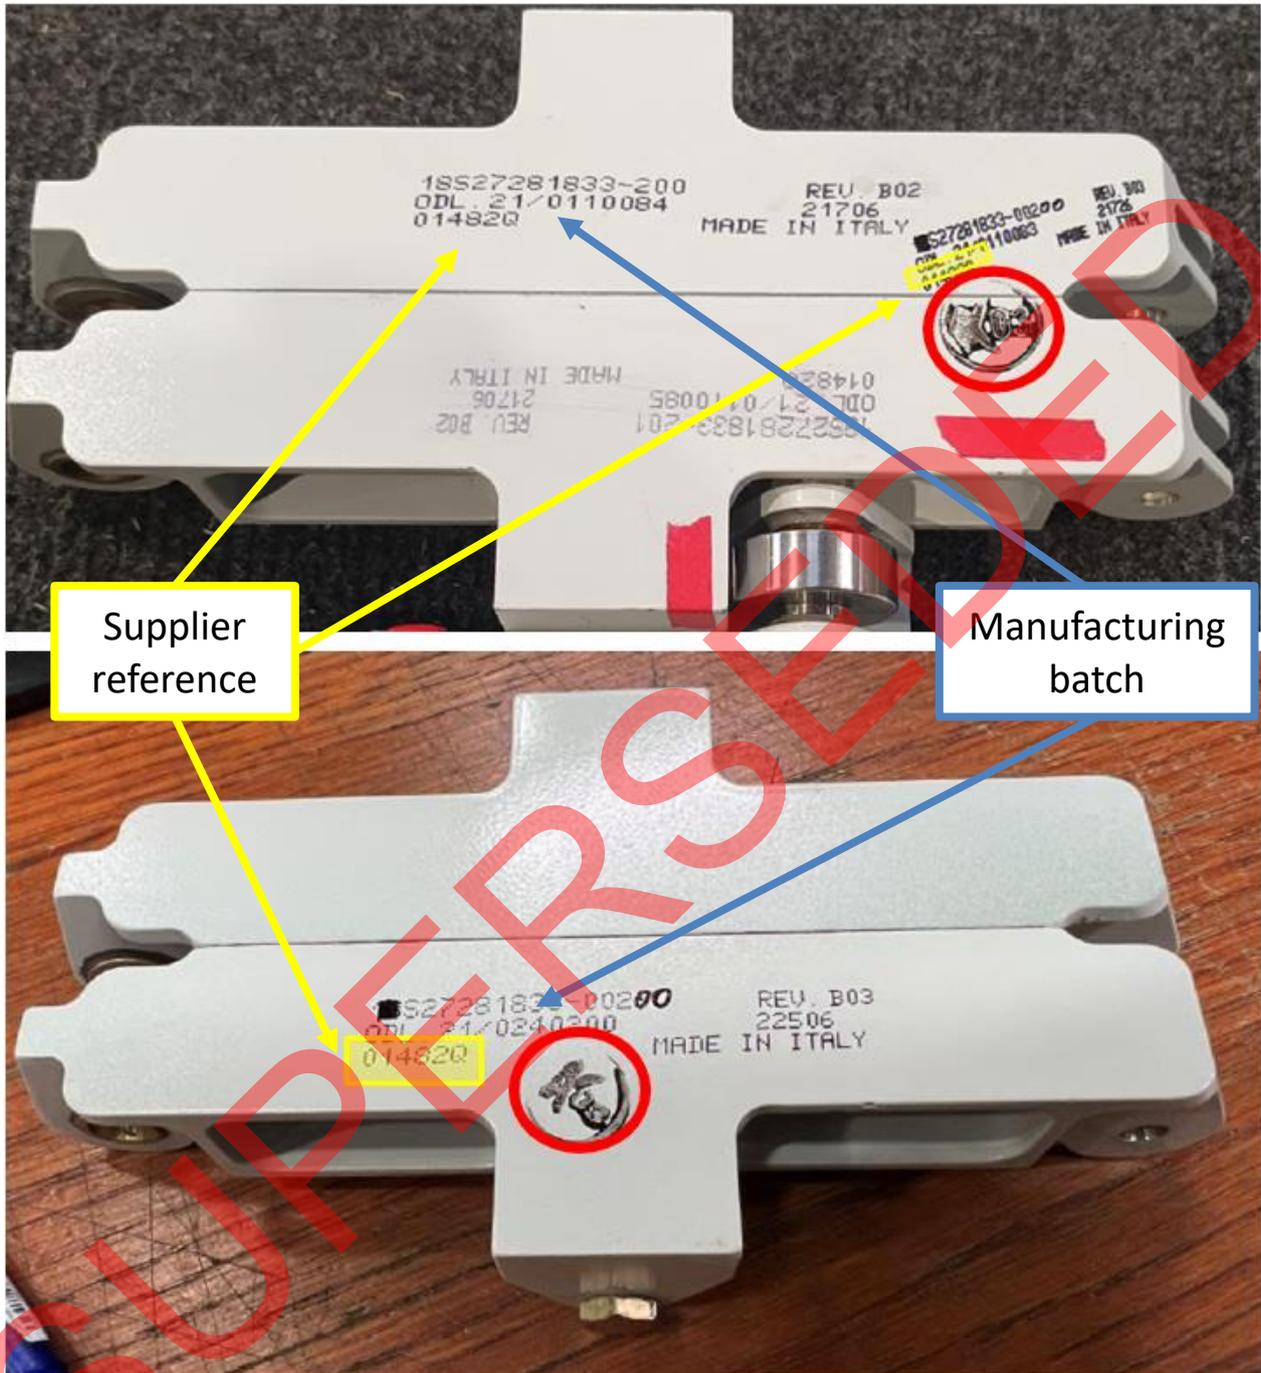
APPENDIX 1 - TLU supplier code and manufacturing batch identification

Note 1: The supplier code and the manufacturing batch of the TLU lever can be identified directly on the part; an example is provided in Appendix 1 of this AD.
